# GRAVELY *Technical* BULLETIN

BULLETIN NO. 1031  
DATE: September 6, 1963  
TO: ALL OUTLETS  
SUBJECT: Fuel Tank Band Breakage Corrected

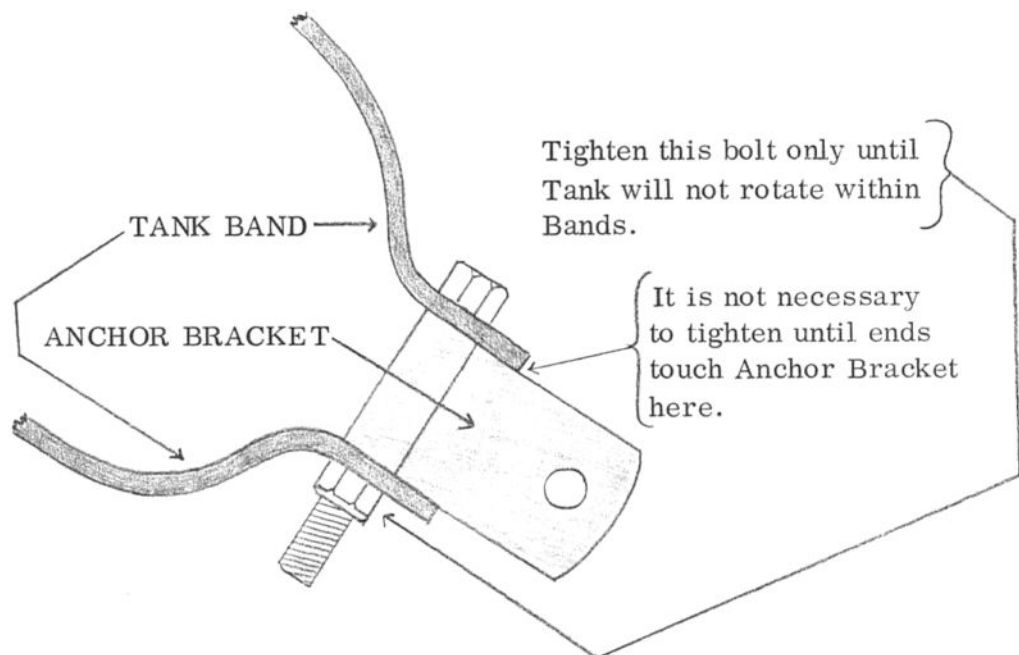
Further engineering checks into the cause of Fuel Tank Band breakage have been conducted.

Cause of this breakage, as determined by these checks, is a fatigue failure brought about by overtightening the Bands during assembly at the factory.

Factory personnel have been instructed to tighten the Tank Bands just enough to keep the Tank from rotating. It is not necessary, as was the previous practice, to tighten until the ends touch the ear that connects the Tank Bands to the Fan Housing.

When replacing Tank Bands, be sure to tighten them only enough so that the Fuel Tank does not rotate within the Bands.
